# **Navajo Abandoned Uranium Mine**

## **Site Screen Report**

## **Castle Tsosie AUM Site**

**March 2010**

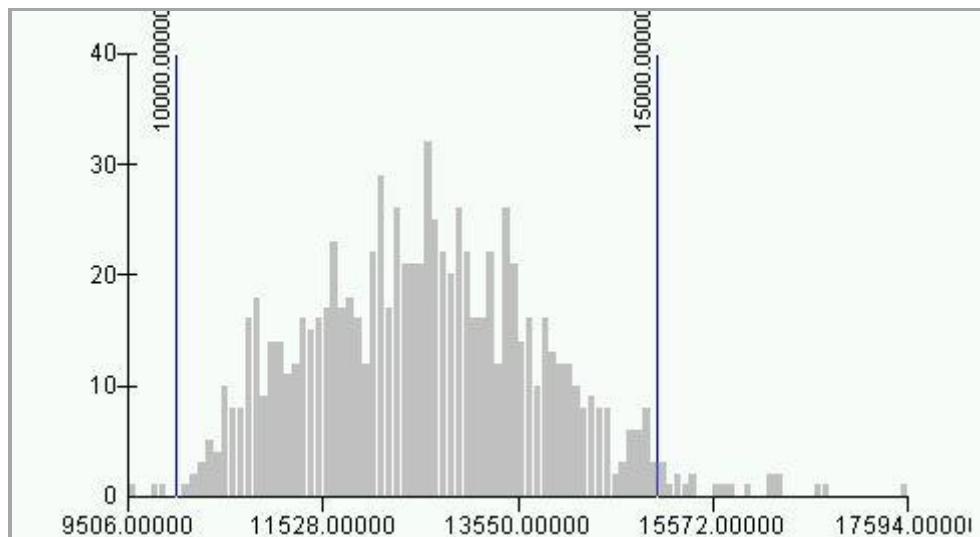
A total of 889 gamma radiation measurements were collected from the mine site, ranging from 9,506 cpm to 17,594 cpm. The measurements are represented in Figures 1 and 2.
